# Direct Application Effluent System

**Name:** Vicki and Tony Greig  
**Location:** Buffalo, South Gippsland  
**Dairy Shed:** 10 Swingover Herringbone  
**Milking Area:** 65ha  
**Herd Size:** 110 Cows  
**Land Type:** Undulating Dryland

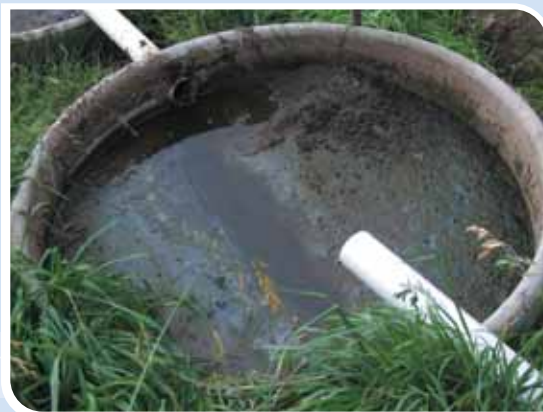
The system applies the same principles used in the two dam effluent systems seen on many larger dairy farms. The effluent and wash down water flows from the dairy and yards into a drop pit, then passes through a two metre length of 100mm PVC pipe into the first pond. The solids component settles to the bottom of the pond, allowing the liquid to flow through a short length of PVC piping into the second pond, which is sited directly below.

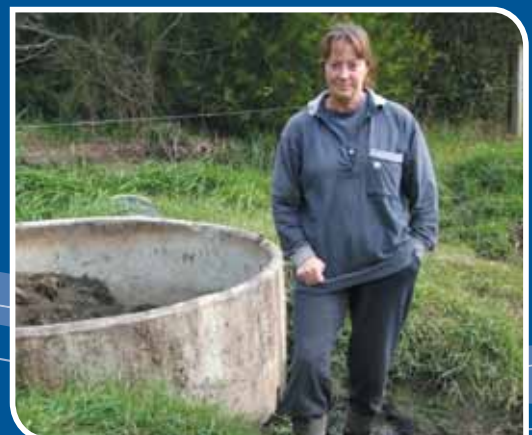
The liquid is then pumped, via 100 metres of 50mm poly piping and flexi hose, to a relatively flat 4ha paddock nearby, where it is irrigated using a manure sprinkler.

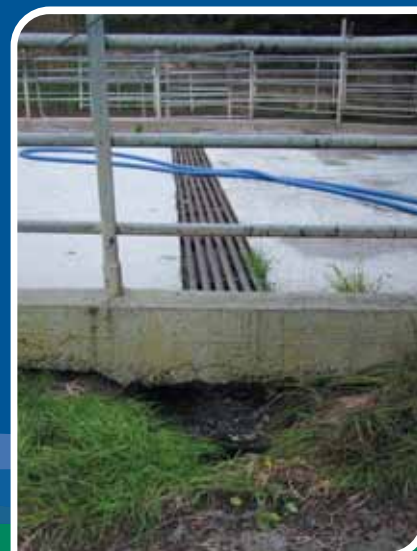
The remaining solids are spread out over other paddocks.

Disadvantages of the system include that there is no capacity for storing the nutrient-rich liquid. This means that Vicki and Tony must irrigate after each milking, regardless of weather conditions or fertiliser requirements. Further, they are not able to recycle the water for washdown, for which they currently use fresh water.
